# ⑨ BUREAU OF SHIPS GROUP TECHNICAL INSPECTION REPORT

⑥ OPERATION CROSSROADS.  
PRINZ EUGEN (Ex-German CA)

TEST ABLE U.S. ⑧

OPERATION CROSSROADS

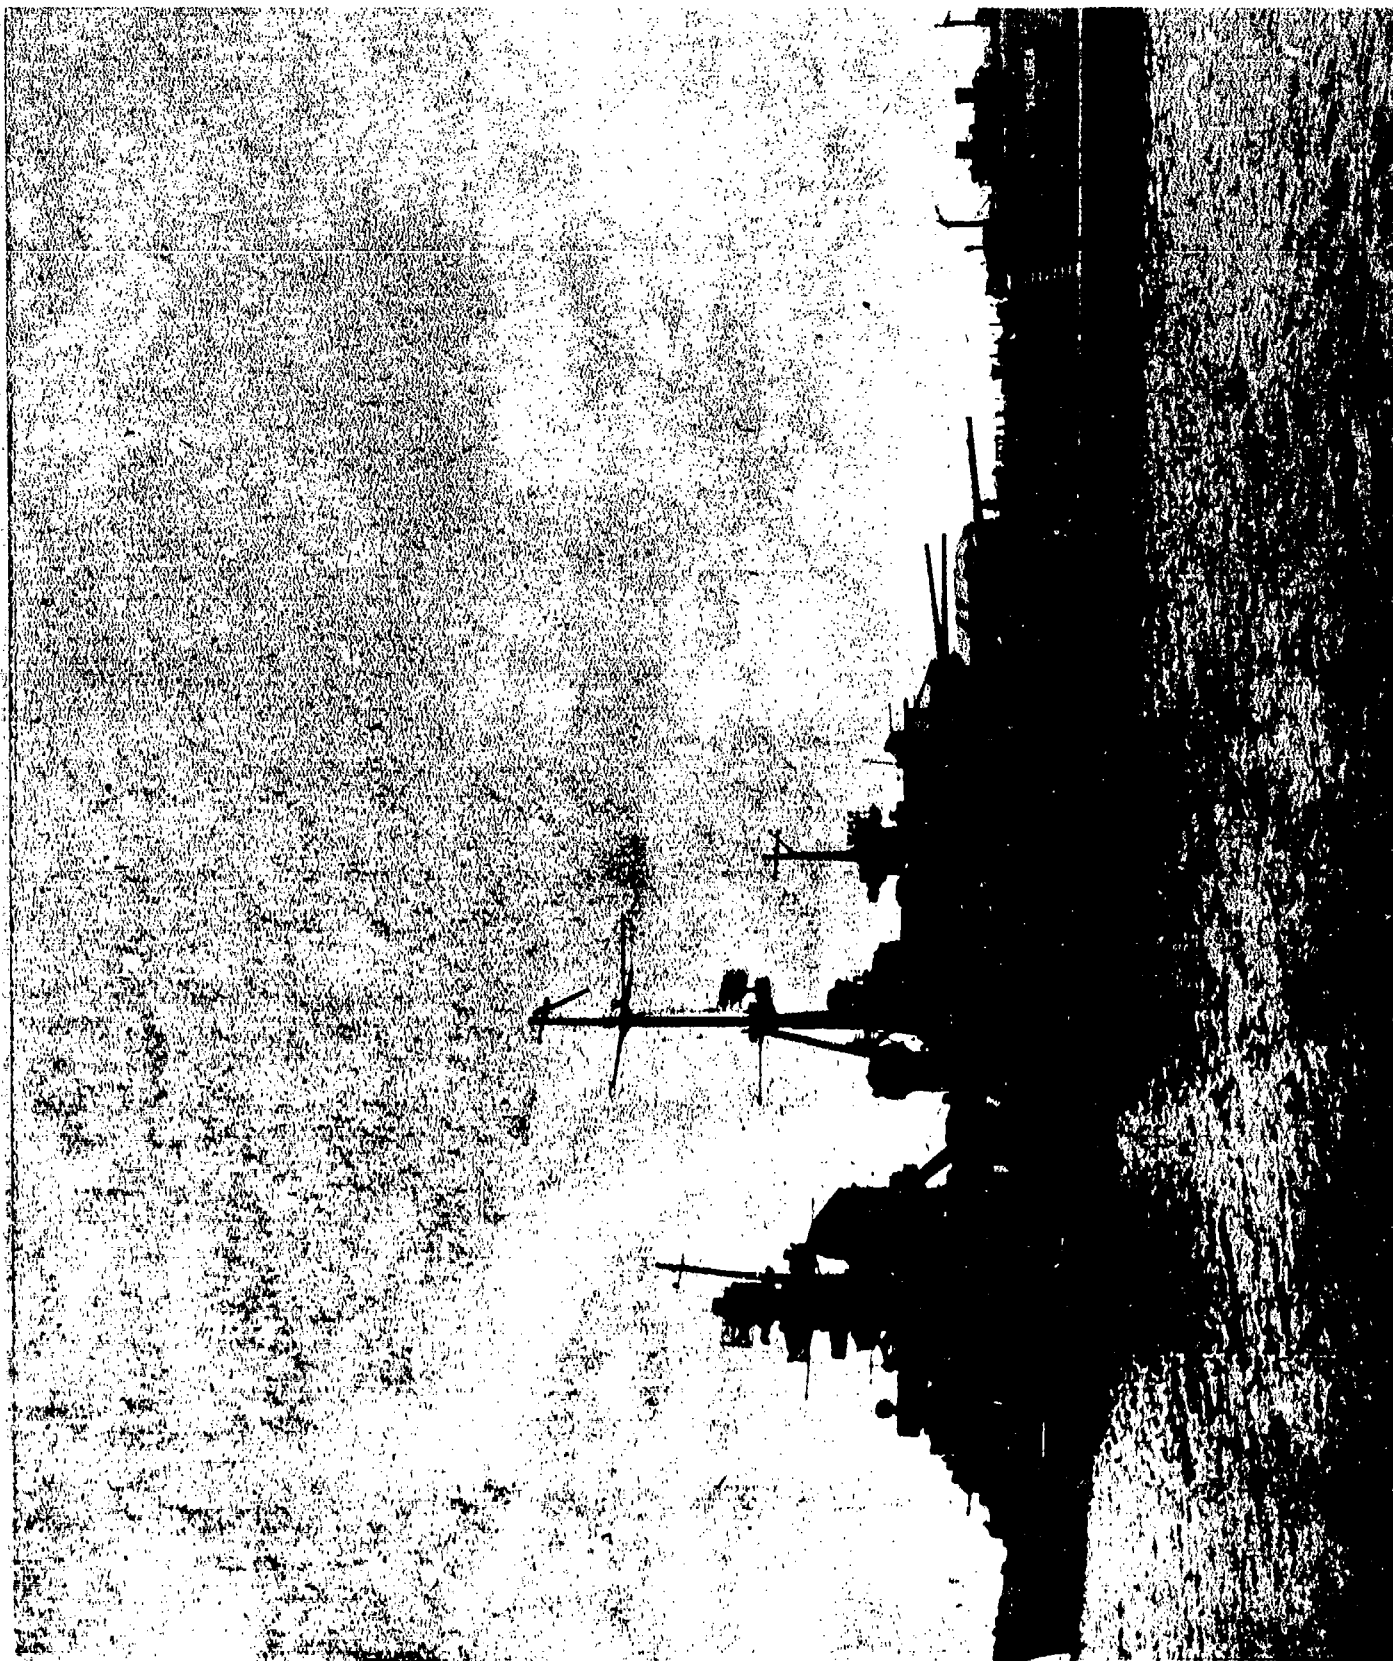
The mainmast tip, 14 1/2 feet long, has snapped off and is hanging loosely in the direction of the blast. (Photos 1773-8, 1893-12, pages 53 , and 54 ).

AA-CR-80-1893-12. View from off port quarter.

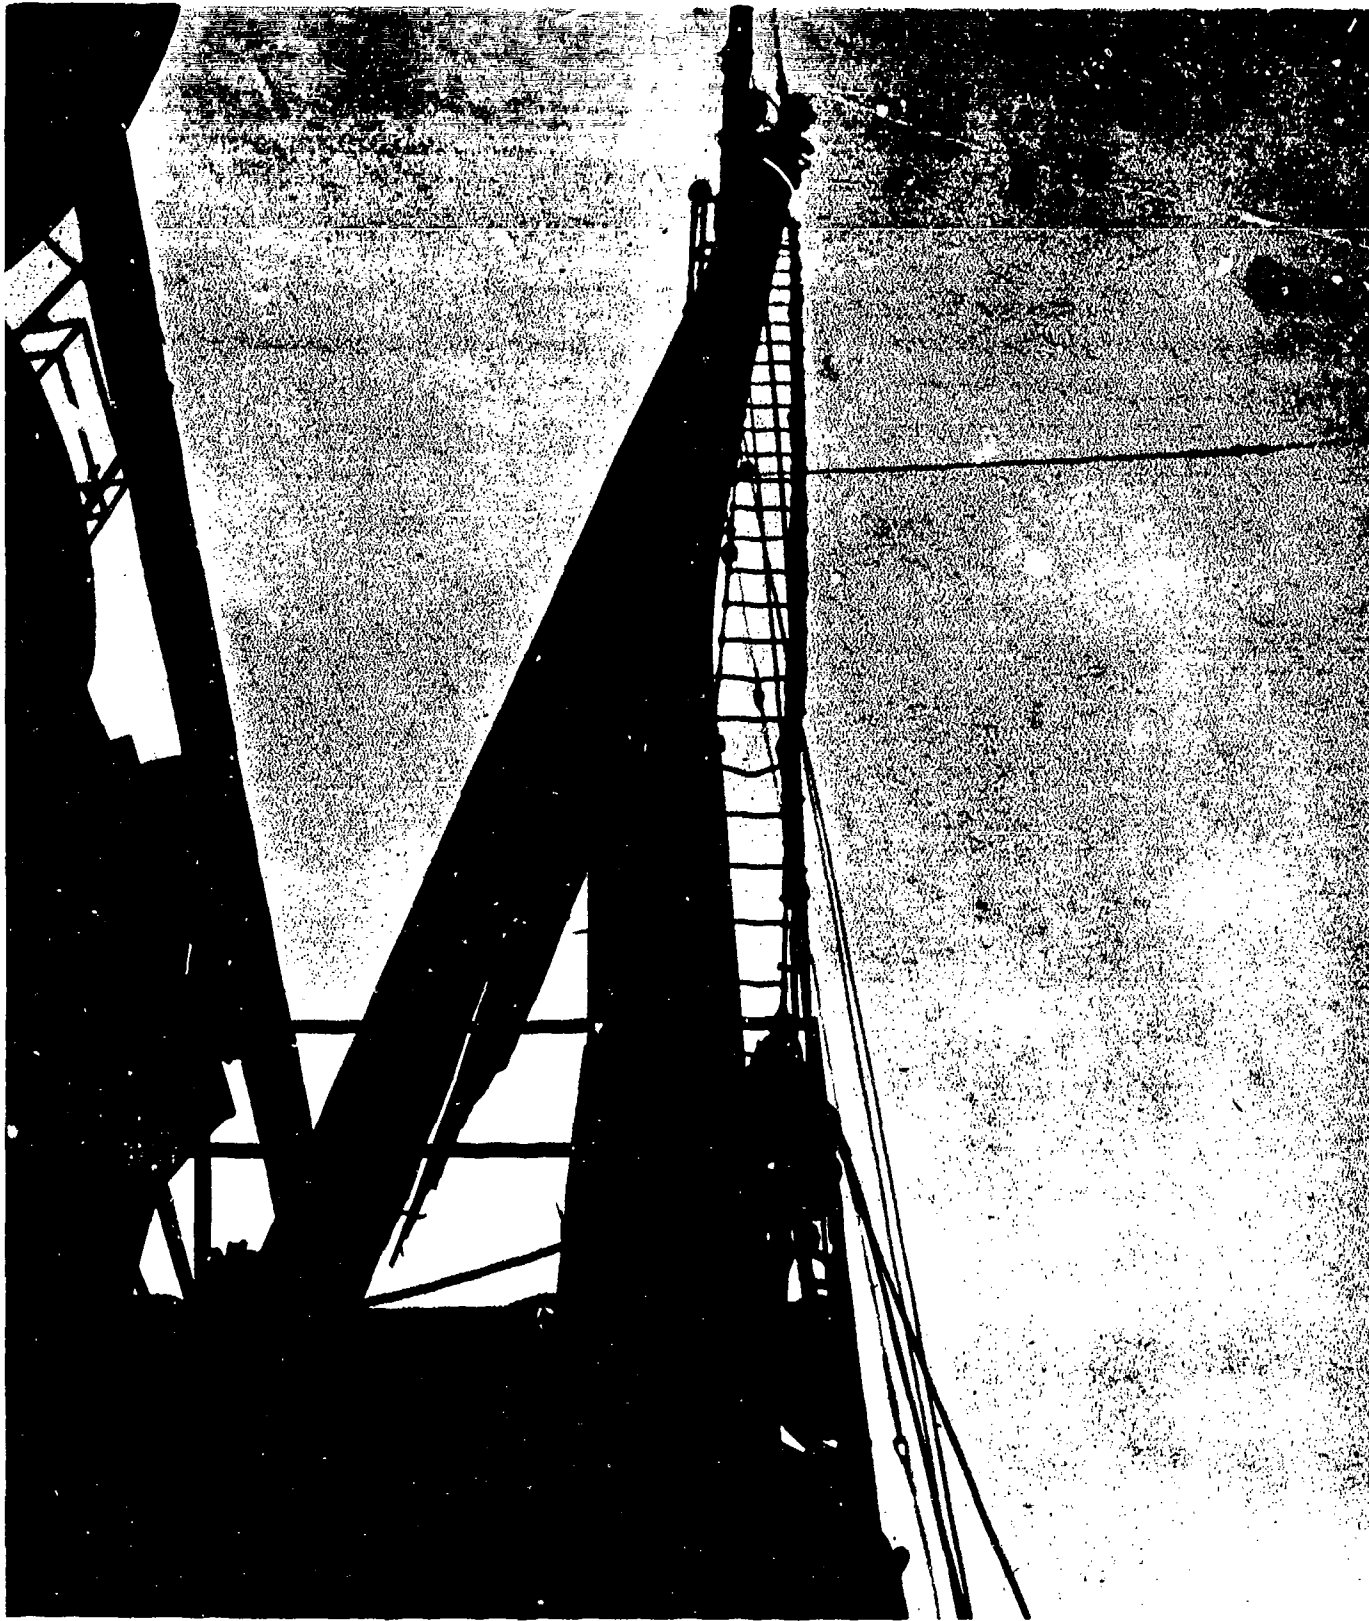
The foremast, a hollow wooden cylinder, is split from the point where it is keyed in the UP position to nearly the topmast point, a distance of approximately 40 feet. The mainmast tip, approximately 14 feet, is broken off and hanging nearby.

AA-CR-92-1774-5. Looking up and aft at fractured foremast.

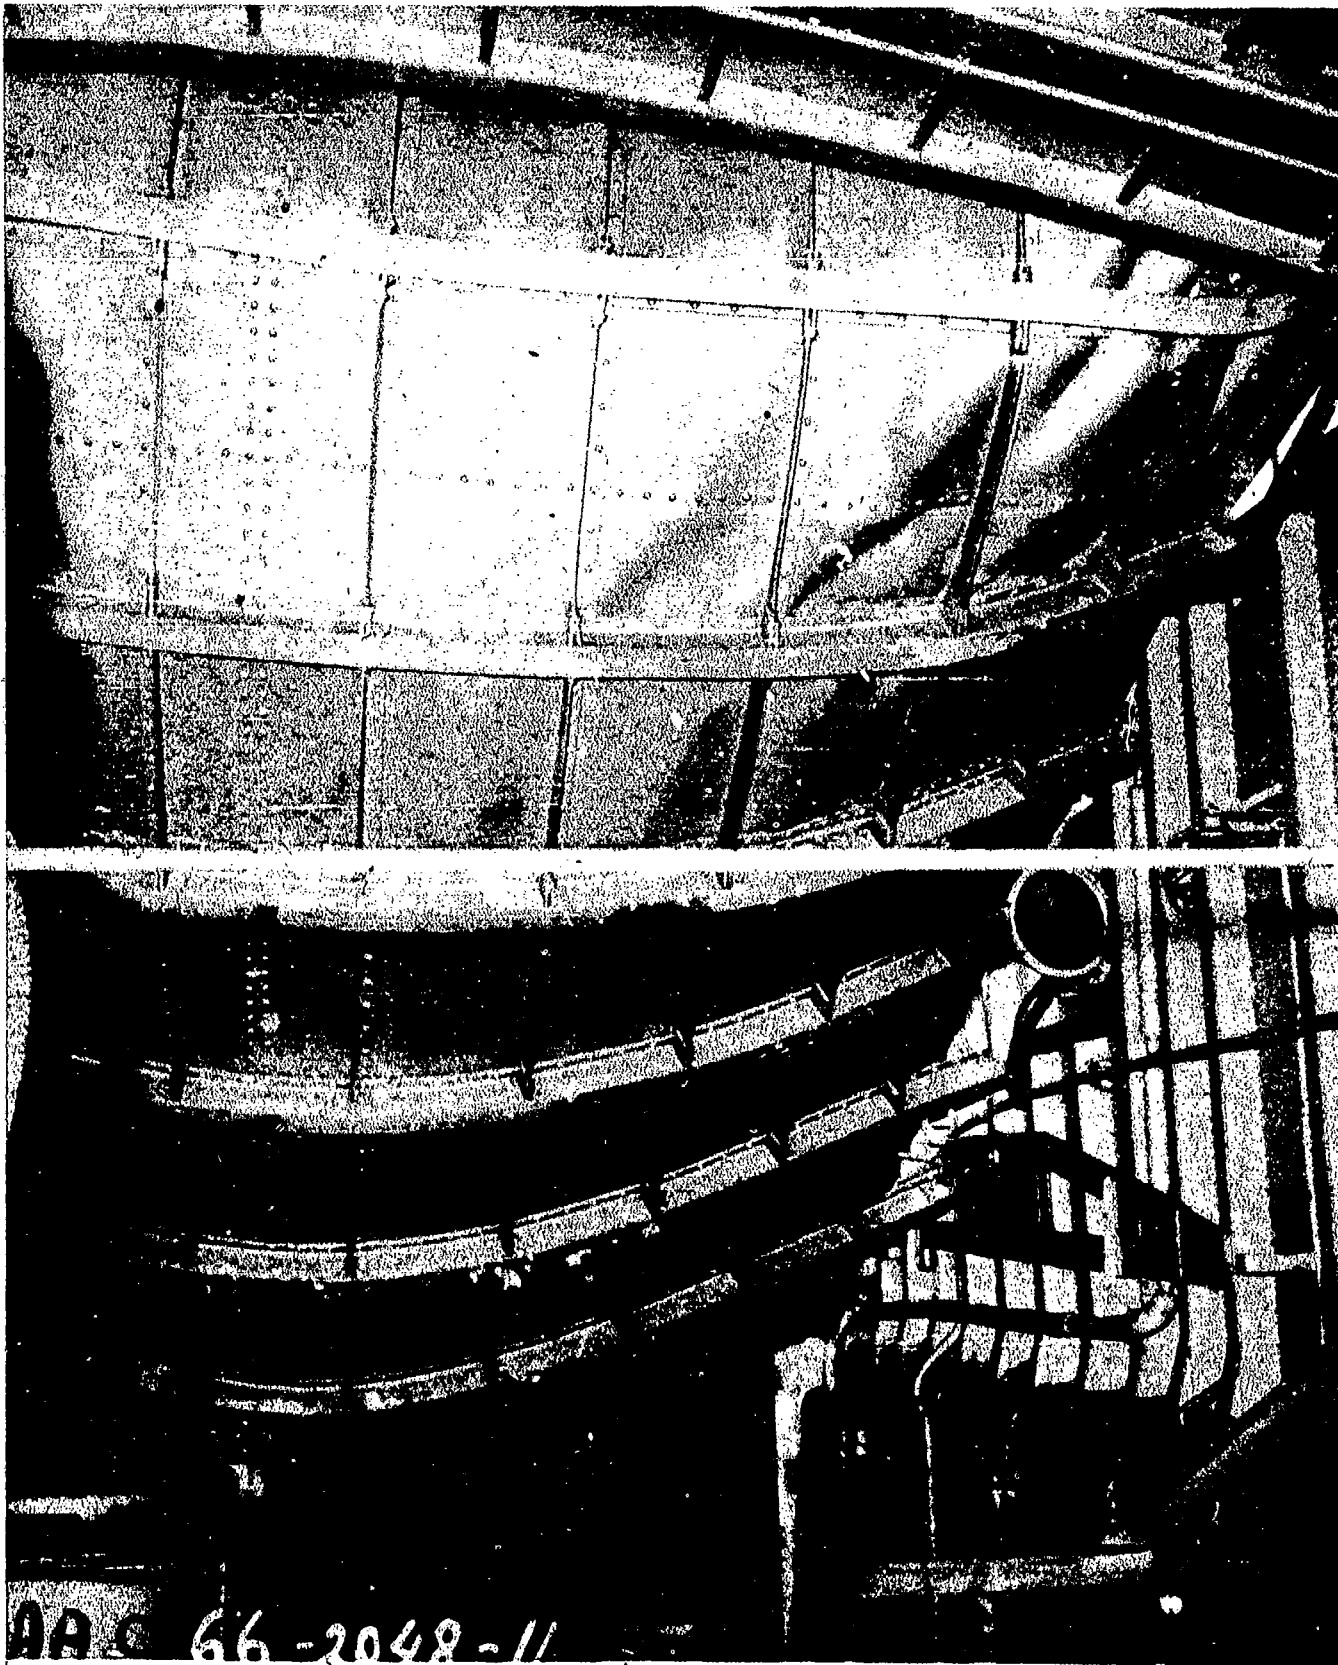
The sliding hangar cover on the second superstructure deck has been blown in and damaged beyond use. This cover is aluminum alloy with six inch "I" stiffeners. (Photos 2049-3, 1774-4, 2049-1, 5, 4, 2048-11 and 2049-2, pages 65 ; 66 , 67 , 68 , 69 , 70 , and 71 ).

AA-CR-66-2048-11. Looking aft and up at wrecked hangar cover.

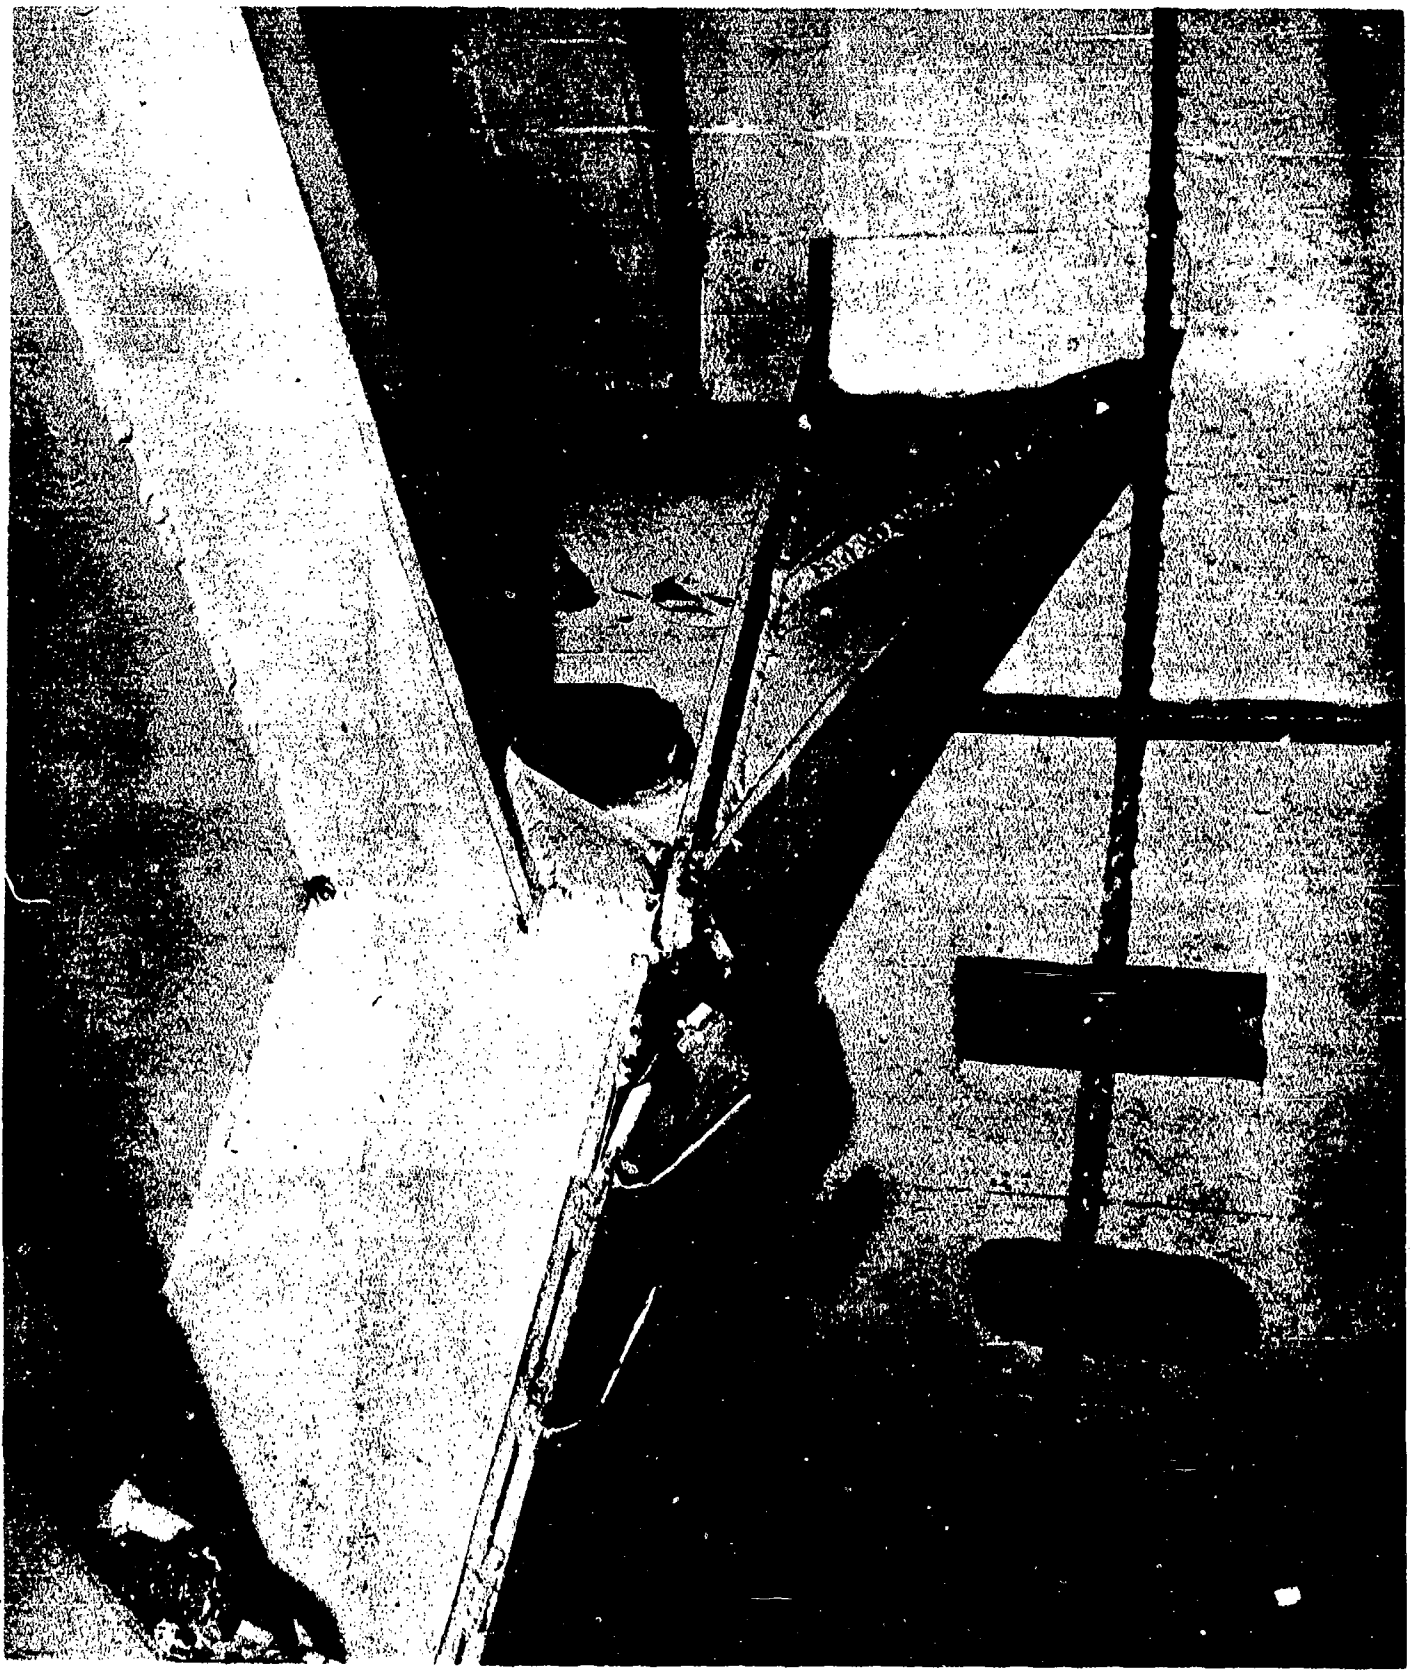
The superstructure deck and supporting structure, aft of turret 2, frames 141.6 to 147.3, show evidence of compression. The two deck longitudinals, two meters to port and starboard of the ship's centerline are built up T's with a 10 x 1/2 inch web, 4 x 3/8 inch flange, and 3 x 1/2 inch face plate. In both cases the flange and face plate connection to brackets from turret 2 have failed. The longitudinals show strain where welded to deck beams at frame 141, 142, 143, 144, 145, and 146. Some of these beams are deflected slightly upwards and some slightly downward. This damage appears to have resulted from combined loading exerted by the blast pressure on the deck and forward face of the turret. (Photos 1850-12, 2049-6, 2049-7, 1850-11, 2049-9, 2049-11, pages 73 , 74 , 75 , 76 , 77 , and 78 ). Joiner bulkheads under the superstructure deck are buckled sharply.

The only panels deflected are a few joiner bulkheads and the sliding cover of the hangar. It is considered that the damage to the superstructure deck aft of turret 2 is the combined effect of pressure loading on the deck and on the face of the turret.

AA-CR-65-1850-12. Connection of longitudinal under superstructure deck, 2 meters to starboard of ships centerline to the face of turret 2. Note buckling of web and failure of flange and face plate.

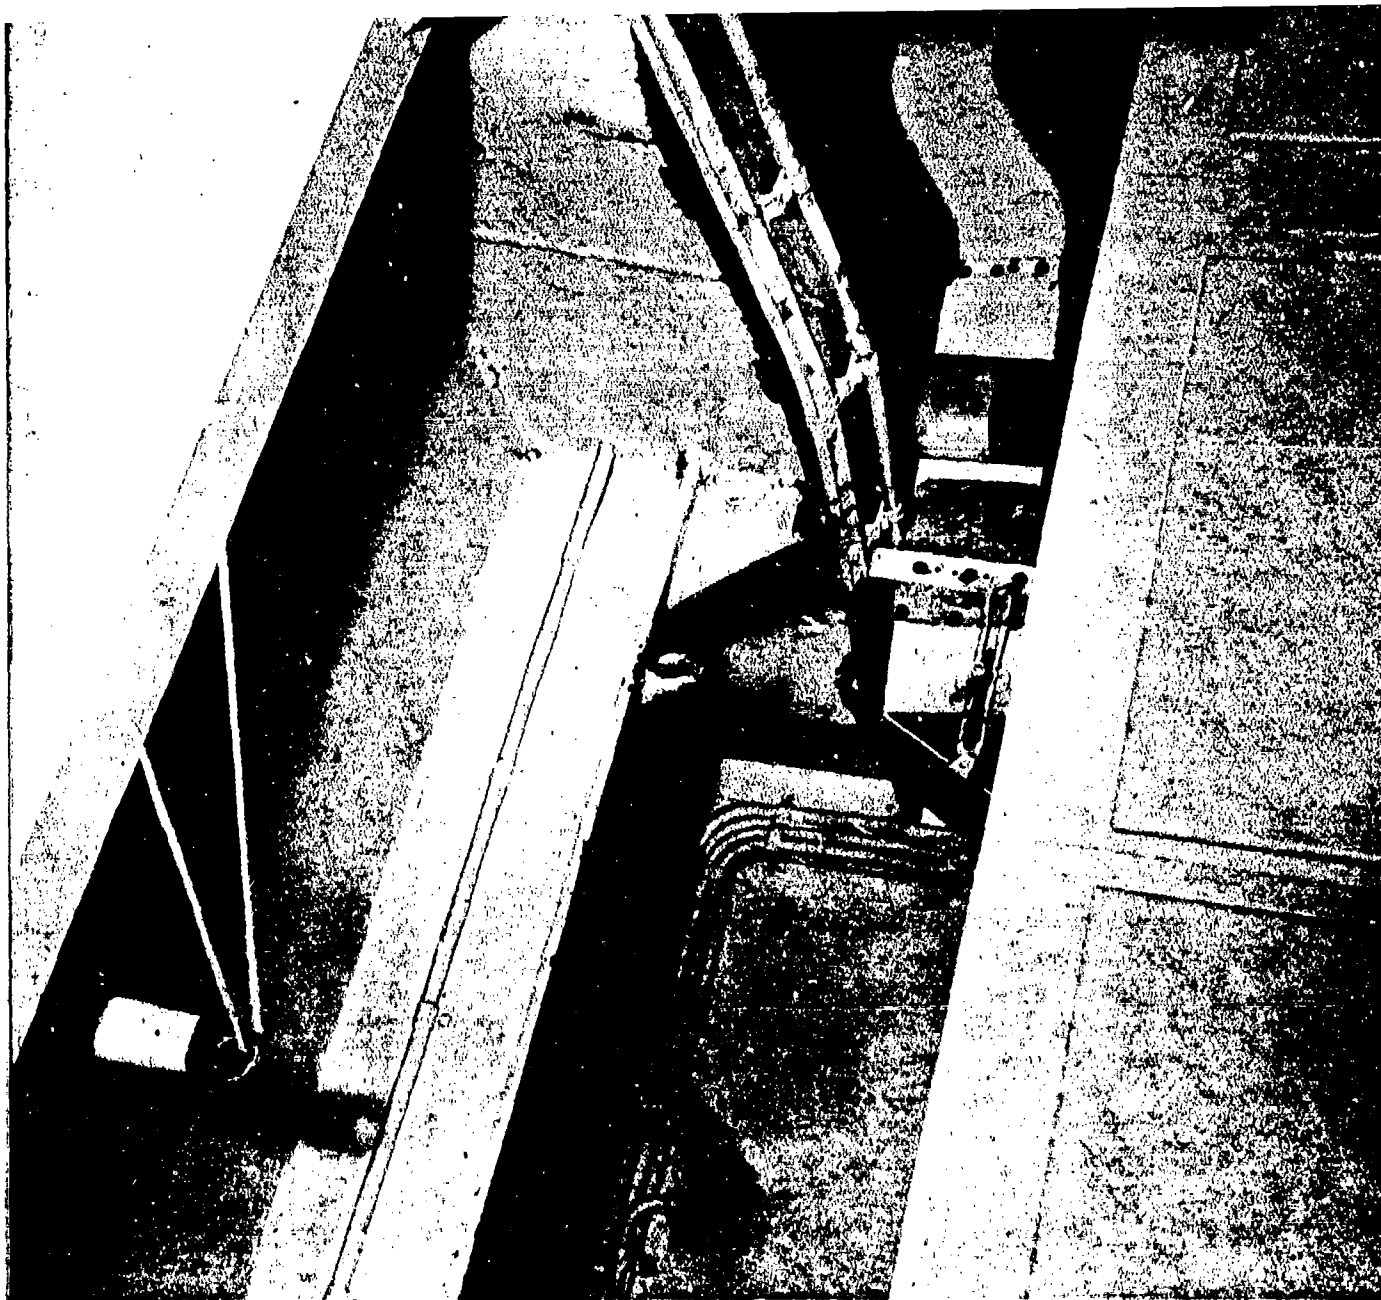
AA-CR-65-1850-11. Longitudinal under superstructure deck, 2 meters to starboard of centerline. View is at frame 42. Note buckled web and failure of intermittent welding between web and flange.

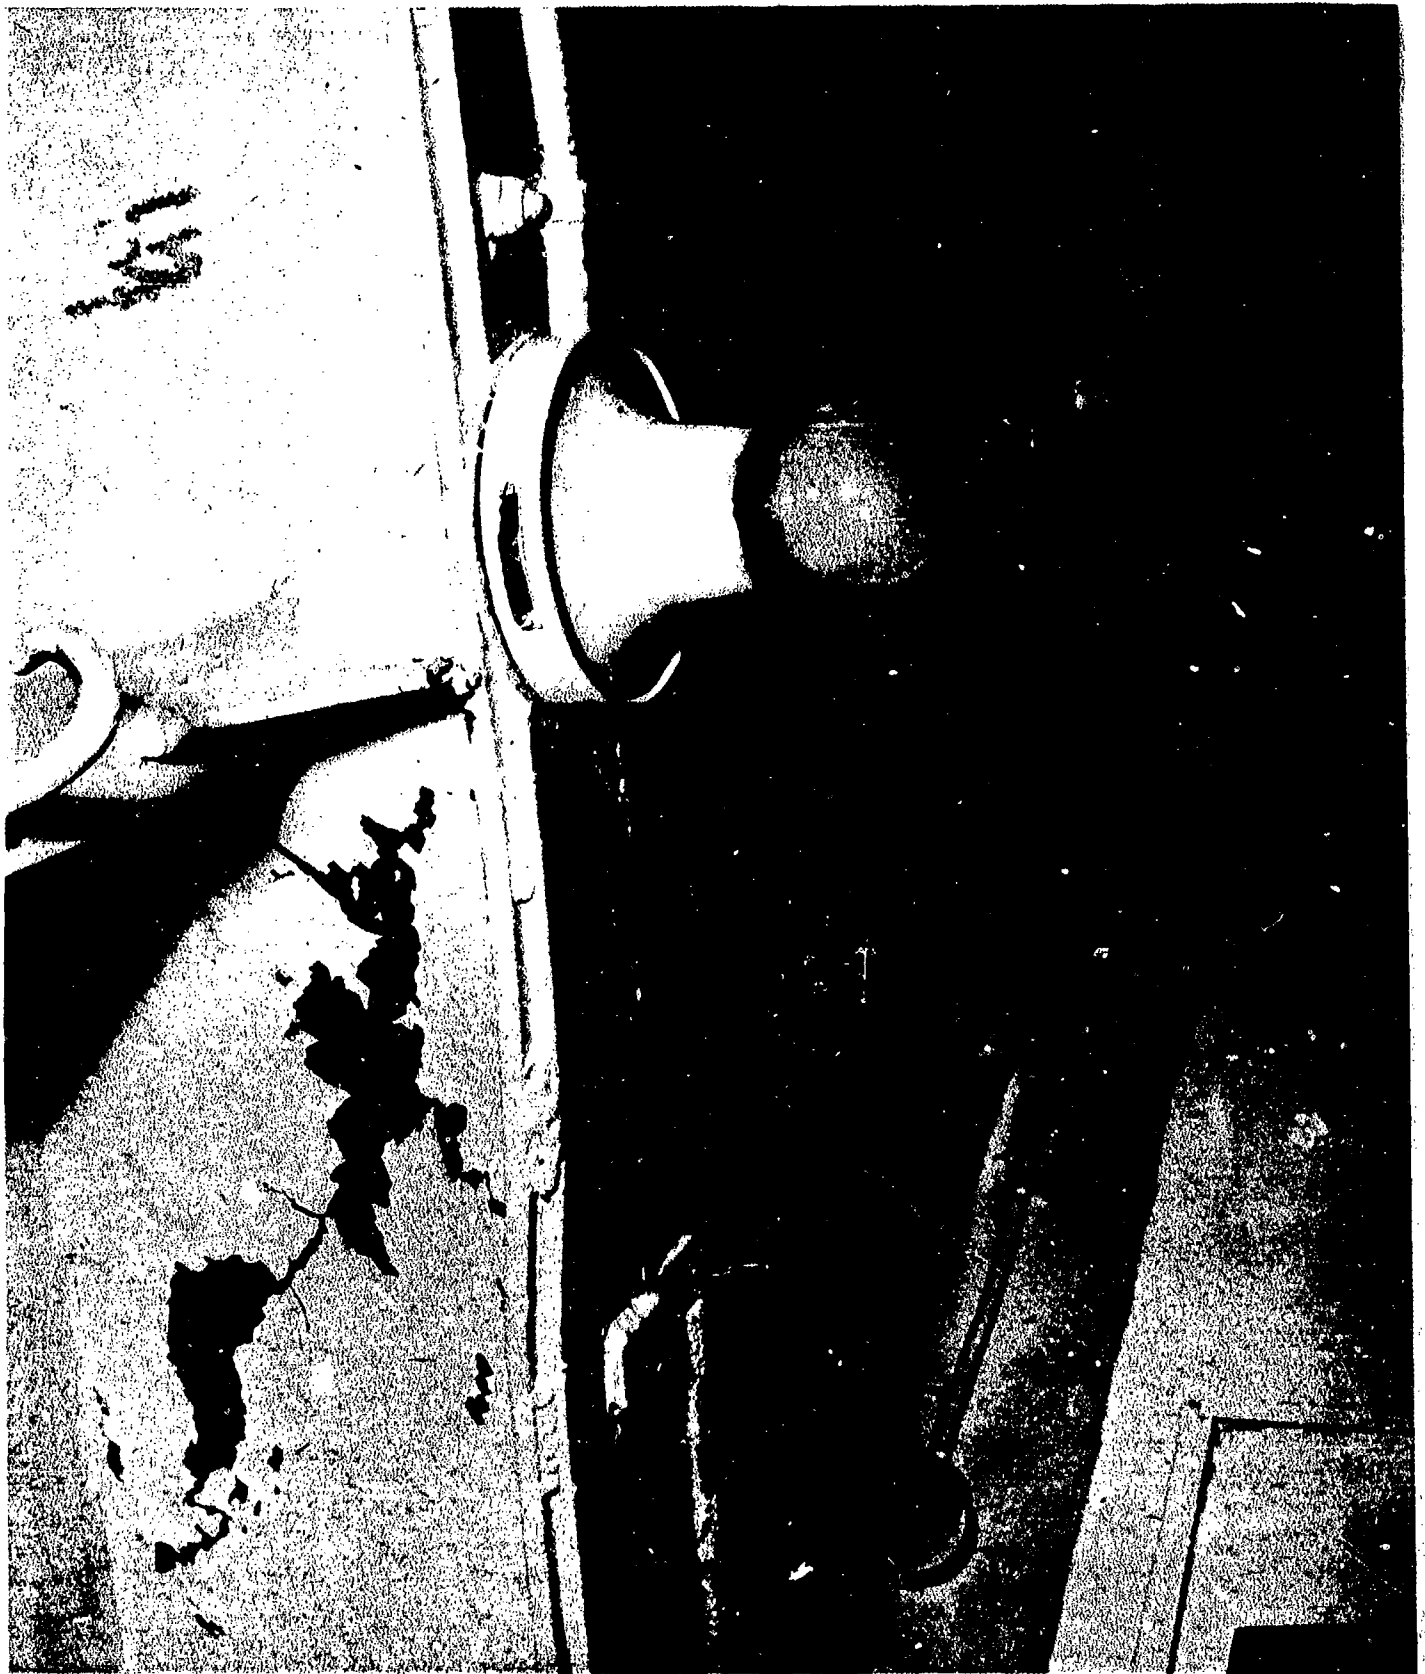
AA-CR-66-2049-9. Looking inboard at longitudinal under super-structure deck, 2 meters to port of centerline. View is at frame 146. Note buckle of web and flange.

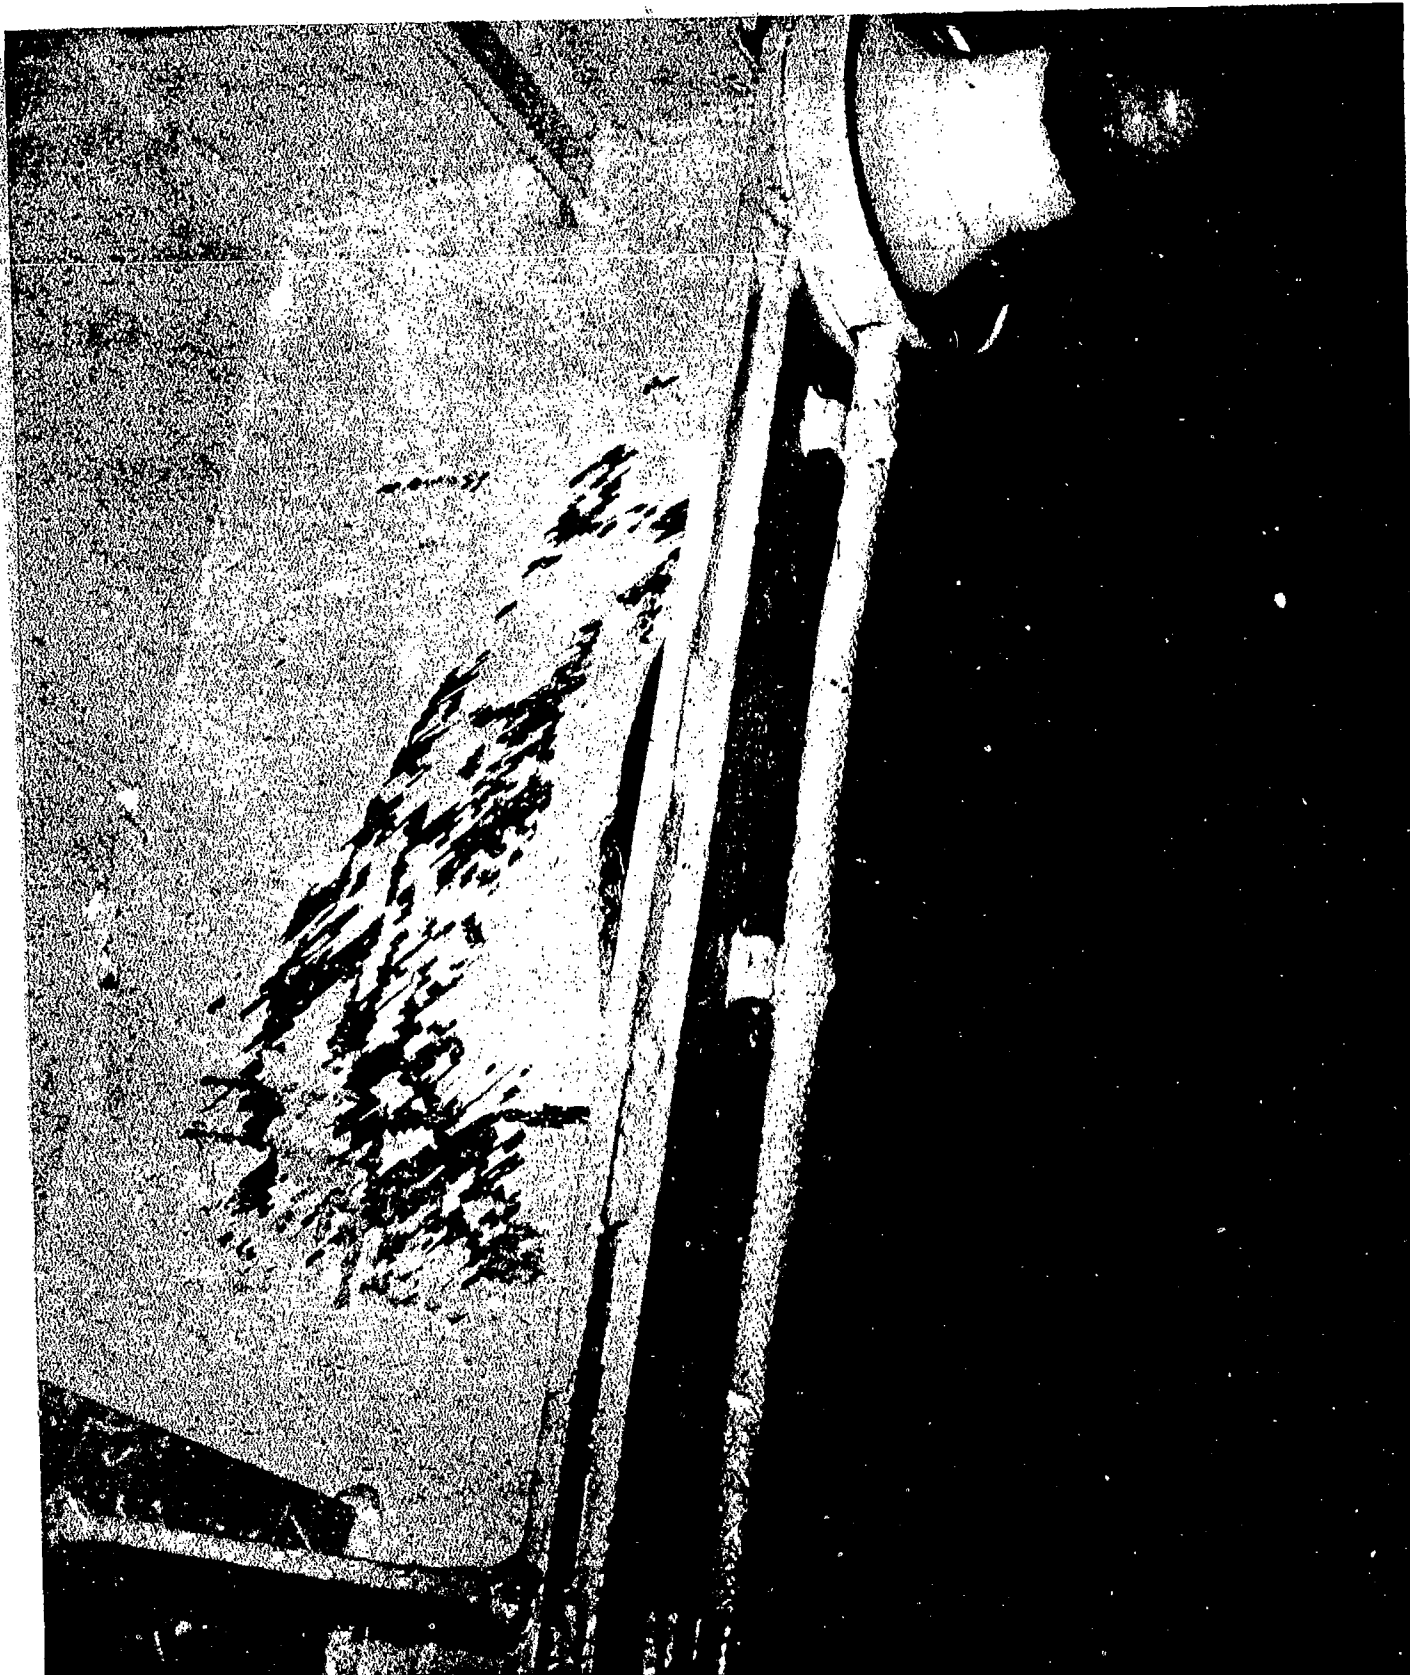
AA-CR-66-2049-11. Looking outboard at longitudinal under the super-structure deck, 2 meters to port of centerline. View is at frame 146. Note buckling of web and flange and failure of intermittent weld between them.
